**Flood Control Project Maintenance
Levee Inspections**

Maintenance Issue Types Only, Levee Inspection Report By Mile - Spring 2018

Knights Landing Ridge Drainage District

Waterway	Bank	Unit Miles	Inspection Start/End	Inspector
Unit No. 01 Knights Landing Ridge Cut	Right	6.36	03/13/2018 03/13/2018	Zach Jojola

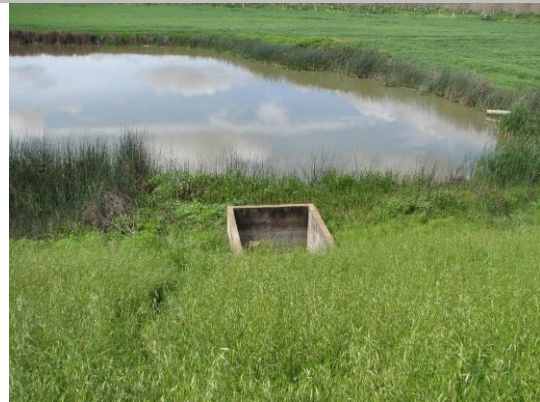
Photo 1 of 3 : UCIP_SP_2018_48010_21582.jpg

Comment Code						
Inspector Comment						
FS_ID:48010 DS_ID:19360 EP_NO: 9302 Repair Type: No Action Needed Crossing Status: Found UCIP Comments: Pipe has been grouted in place under permit 18987, 2015Pipe completely rusted through on LS slope of levee at toe/headwall of concrete distribution box. Pipe needs replacement or proper abandonment. Pipe not visible at outlet. FIELD_STRUCT_DESC: *ABANDONED* 36-inch corrugated metal drainage pipe through the levee, 27 feet below the crown. Slide gate on the waterside (WS) end. 12-foot by 6-foot concrete box on the landside (LS) end. (36-inch pipe [HLM 1.62] authorized under Automatic Board Order (ABO) issued as Permit No. 9302, 1974 - Barbara Lowe Elliott; 36-inch pipe abandoned by removing ends and pumping pipe full of concrete under Permit No. 18987, 2016 - Knaggs Ranch, LLC, care of John Brennan). [Additional Reference(s): DWR Levee Log, 1990. USACE Sacramento O&M Manual 127, June 1953, (Station 0+30)]. FS Date: 5/16/2016 3:59:29 PM

Concrete distribution box on LS toe.

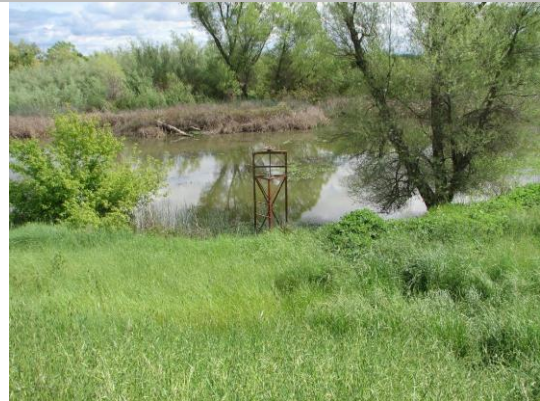
Photo 2 of 3 : UCIP_SP_2018_48010_21581.jpg

Slide gate on metal stand on WS toe. Pipe opening not visible.

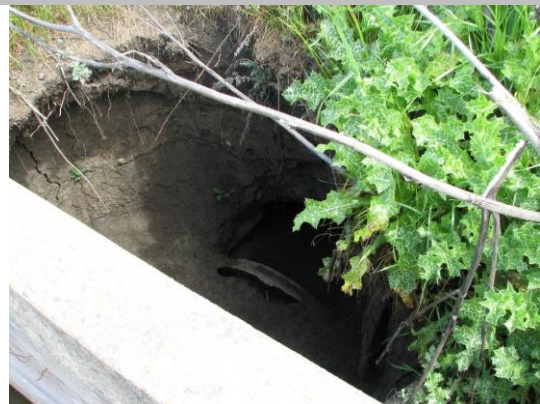
Photo 3 of 3 : UCIP_SP_2018_48010_21580.jpg

FS_ID:48010
DS_ID:19360
EP_NO: 9302
Repair Type: No Action Needed
Crossing Status: Found
UCIP Comments: Pipe has been grouted in place under permit 18987, 2015Pipe completely rusted through on LS slope of levee at toe/headwall of concrete distribution box. Pipe needs replacement or proper abandonment. Pipe not visible at outlet.
FIELD_STRUCT_DESC: *ABANDONED* 36-inch corrugated metal drainage pipe through the levee, 27 feet below the crown. Slide gate on the waterside (WS) end. 12-foot by 6-foot concrete box on the landside (LS) end. (36-inch pipe [HLM 1.62] authorized under Automatic Board Order (ABO) issued as Permit No. 9302, 1974 - Barbara Lowe Elliott; 36-inch pipe abandoned by removing ends and pumping pipe full of concrete under Permit No. 18987, 2016 - Knaggs Ranch, LLC, care of John Brennan). [Additional Reference(s): DWR Levee Log, 1990. USACE Sacramento O&M Manual 127, June 1953, (Station 0+30)].

Pipe failure at connection to concrete box on LS toe.

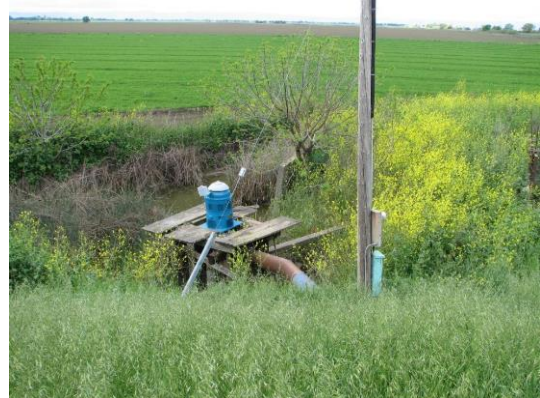
Photo 1 of 1 : UCIP_SP_2018_11067_18431.jpg

Comment Code					
Inspector Comment					
FS_ID:11067 DS_ID:19364 EP_NO: 9307 Repair Type: Non-Urgent Crossing Status: Found UCIP Comments: Siphon breaker on LS burried or broken off and missing. FIELD_STRUCT_DESC: 1 of 2: 14-inch steel drainage pipe through the levee, 5.4 feet below the crown. Pump house on a pile structure at the landside (LS) toe. Siphon breaker on the LS slope. Service pole and anchor at the LS toe. (14-inch pipe [HLM 2.62] authorized under Automatic Board Order (ABO) issued as Permit No. 9307, 1974 - Azalene E. Lowe; a 12-foot section of an existing 14-inch pipe on LS replaced and name change under Permit No. 9307-1, 2016 - Ann Grube). [Additional Reference(s): DWR Levee Log, 1990. USACE Sacramento O&M Manual 127, June 1953, (Station 123+25)]. FS Date: 4/5/2013

Pump and pipe on LS toe.

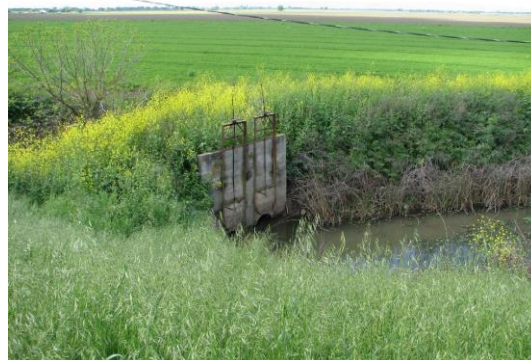
Photo 3 of 3 : UCIP_SP_2018_13205_21605.jpg

Comment Code						
Inspector Comment						
FS_ID:13205						
DS_ID:19391						
EP_NO: 9307						
Repair Type: Non-Urgent						
Crossing Status: Found						
UCIP Comments: Walkway to actuator slide gate is missing. No method of actuating slide gate.						
FIELD_STRUCT_DESC: 2 of 2: 48-inch by 48-inch reinforced concrete box drainage culvert through the levee, 23 feet below the crown.						
Walkway to slide gate on the waterside (WS) end. Concrete headwalls on both ends. Service pole and anchor at the landside (LS) toe.						
Concrete headwalls on both ends. (four foot by four foot culvert [HLM 2.62] authorized under Automatic Board Order (ABO) issued as Permit No. 9307, 1974 - Azalene E. Lowe). [Additional Reference(s): DWR Levee Log, 1990. USACE Sacramento O&M Manual 127, June 1953, (Station 123+55.5)].						
FS Date: 4/5/2013

Inlet located next to concrete headwall on LS toe.

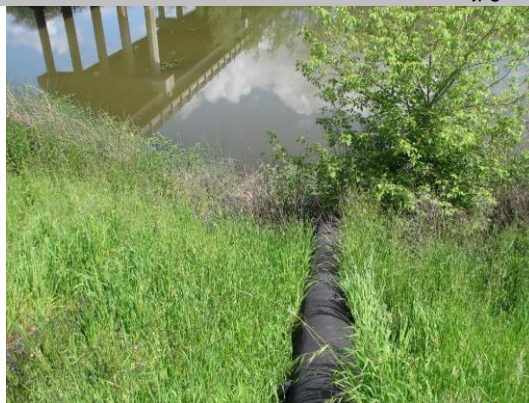
Photo 1 of 3 : UCIP_SP_2018_16105_27207.jpg

Pipe on WS slope.

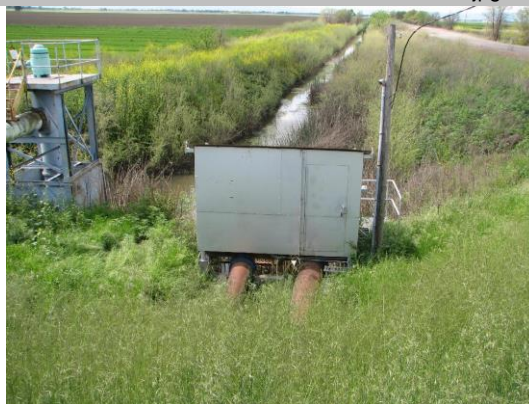
Photo 2 of 3 : UCIP_SP_2018_16105_27209.jpg

Pumphouse and pipe on LS toe.

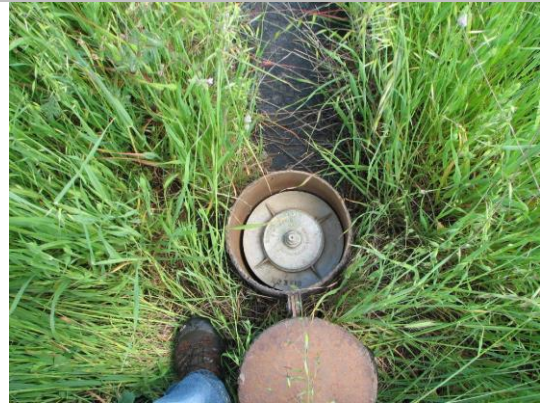
Photo 3 of 3 : UCIP_SP_2018_16105_27210.jpg

Siphon breaker on WS slope.

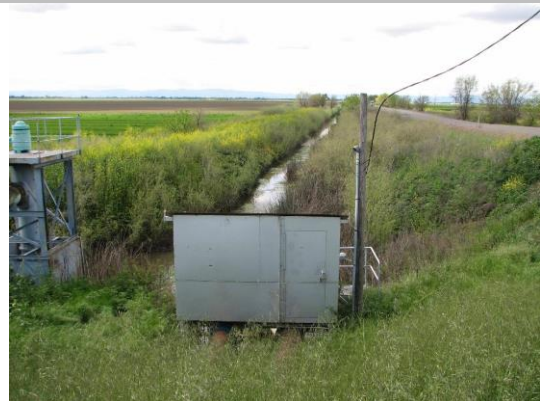
Photo 1 of 3 : UCIP_SP_2018_16106_27213.jpg

Pumphouse and pipe on LS toe.

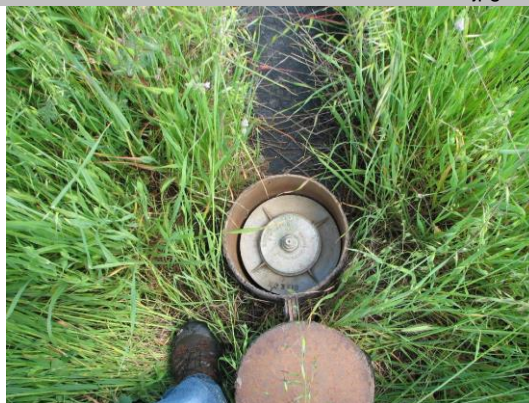
Photo 2 of 3 : UCIP_SP_2018_16106_27212.jpg

Siphon breaker on WS slope

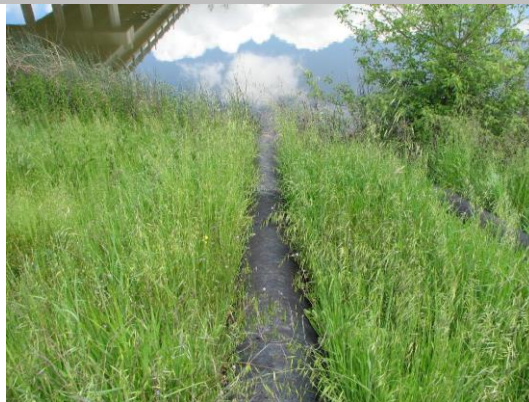
Photo 3 of 3 : UCIP_SP_2018_16106_27214.jpg

Pipe on WS slope.

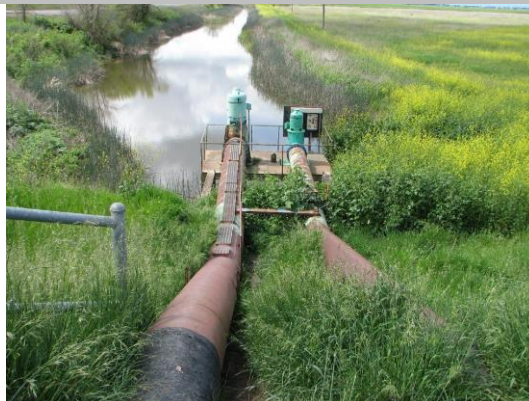
Photo 1 of 2 : UCIP_SP_2018_11244_18603.jpg

Pump on steel pile structure at LS toe with pipe on slope.

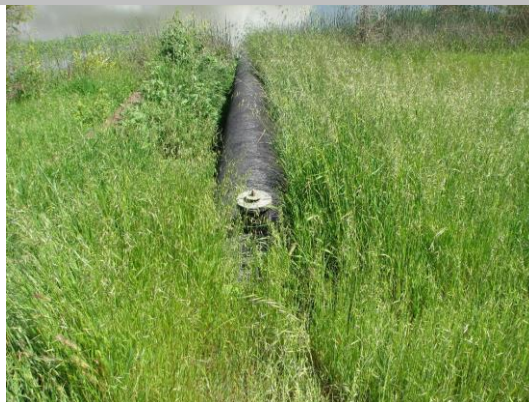
Photo 2 of 2 : UCIP_SP_2018_11244_18602.jpg

Siphon breaker on pipe at WS slope.

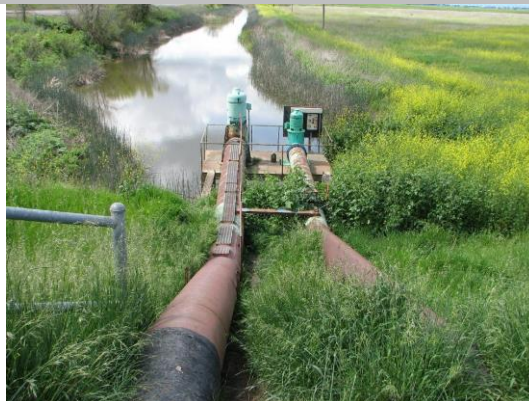
Photo 1 of 2 : UCIP_SP_2018_11247_18605.jpg

Pump on steel pile structure with butterfly valve and pipe on LS slope.

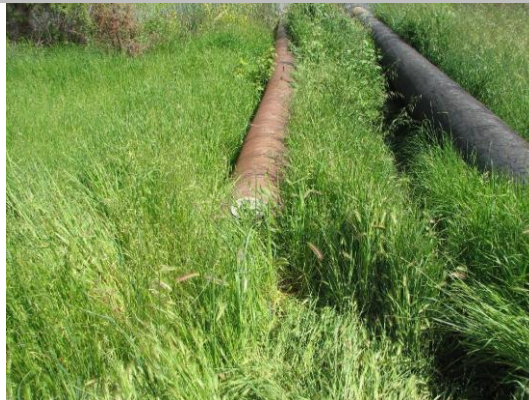
Photo 2 of 2 : UCIP_SP_2018_11247_18604.jpg

Siphon breaker on pipe at WS shoulder.

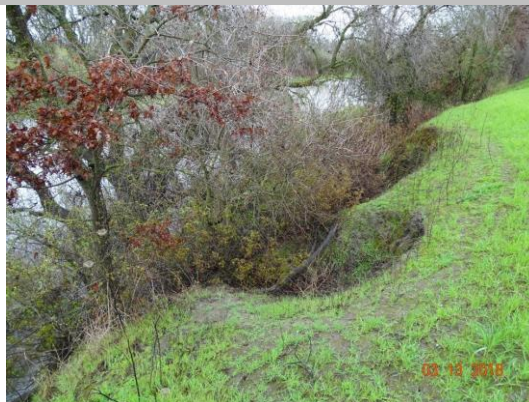
Photo 1 of 3 : SP_2018_NA0008_256_20_20180313_00045.jpg

LM Start	3.50	Rating **	U	Issue No.	20
LM End	3.50	Issue Type +	Ma	Location *	WS
Category	Earthen Levee			GPS Latitude/Longitude	
				Start	End
Item	Erosion / Bank Caving			38.759910 °	38.759910 °
				-121.696920 °	-121.696920 °
DWR ID	DWR_NA0008_01_f_2015_20				
Comment Code					
E2 : Schedule repair of erosion site prior to the next inspection.					
Inspector Comment

Updated view of erosion on the waterside slope. Spring 2018.

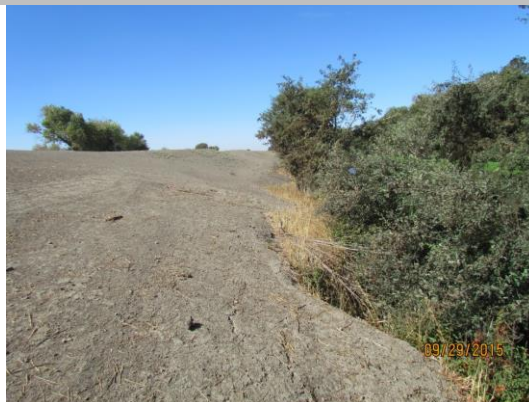
Photo 2 of 3 : SP_2018_NA0008_256_20_20180306_00006.jpg

View of the erosion on the waterward side of the levee looking upstream.
Fall 2015.

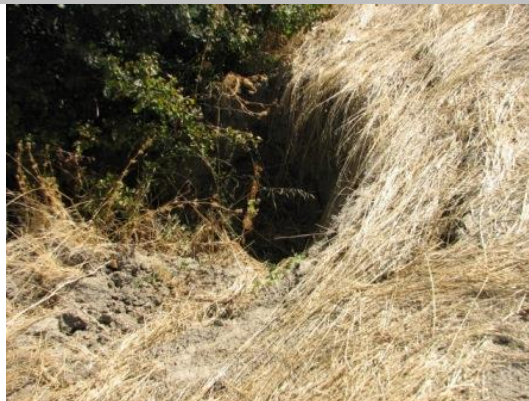
Photo 3 of 3 : SP_2018_NA0008_256_20_20180306_00005.jpg

LM Start	3.50	Rating **	U	Issue No.	20 (cont)	
LM End	3.50	Issue Type +	Ma	Location *	WS	
Category	Earthen Levee			GPS Latitude/Longitude		
				Start		End
Item	Erosion / Bank Caving			38.759910 °	38.759910 °	
				-121.696920 °	-121.696920 °	
DWR ID	DWR_NA0008_01_f_2015_20					
Comment Code						
E2 : Schedule repair of erosion site prior to the next inspection.						
Inspector Comment

Deep erosion at the bottom of the waterside slope 3-4 foot cut. Fall 2013

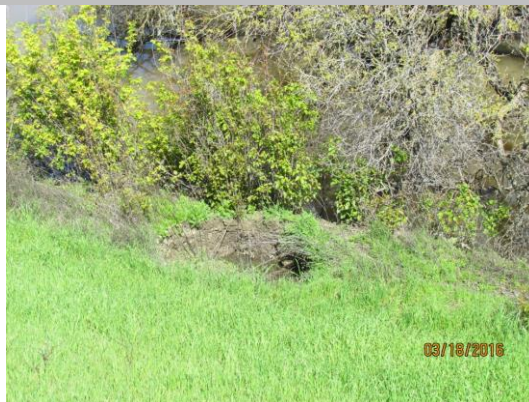
Photo 1 of 1 : SP_2018_NA0008_256_30_20180306_00011.jpg

LM Start	3.78	Rating **	M	Issue No.	30
LM End	3.78	Issue Type +	Ma	Location *	WS
Category	Earthen Levee			GPS Latitude/Longitude	
				Start	End
Item	Erosion / Bank Caving			38.762886 °	38.762886 °
				-121.700406 °	-121.700406 °
DWR ID	DWR_NA0008_01_s_2017_30				
Comment Code					
E2 : Schedule repair of erosion site prior to the next inspection.					
Inspector Comment					
Hole is at the toe of the levee on the waterward side.

View of the erosion at the toe of the levee on the waterward side. Spring 2016.

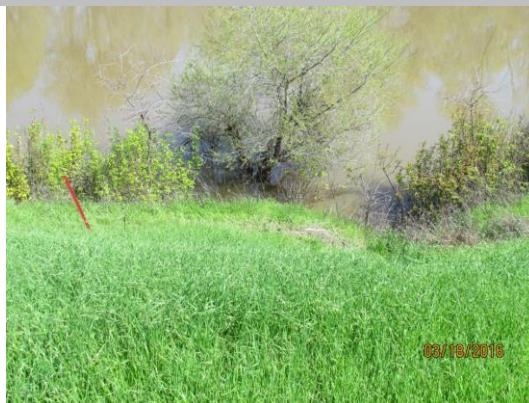
Photo 1 of 1 : SP_2018_NA0008_256_31_20180306_00012.jpg

LM Start	3.86	Rating **	M	Issue No.	31
LM End	3.86	Issue Type +	Ma	Location *	WS
Category	Earthen Levee			GPS Latitude/Longitude	
				Start	End
Item	Erosion / Bank Caving			38.763751 °	38.763751 °
				-121.701398 °	-121.701398 °
DWR ID	DWR_NA0008_01_s_2018_31				
Comment Code					
E1 : Note and monitor erosion site.					
Inspector Comment					
Erosion at the toe of the levee. LMA is monitoring erosion with stakes.

View of the erosion at the toe of the levee on the waterward side. Spring 2016.

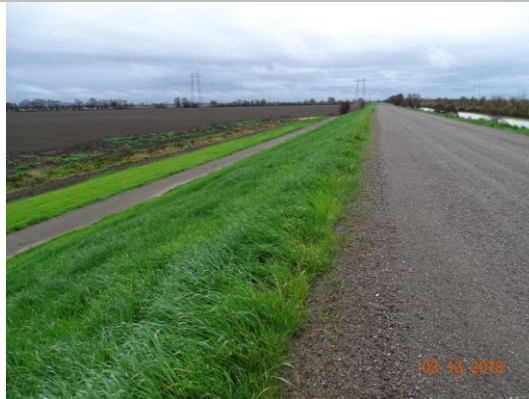
Photo 1 of 1 : SP_2018_NA0008_257_21_20180313_00023.jpg

LM Start	0.97	Rating **	M	Issue No.	21
LM End	1.88	Issue Type +	Ma	Location *	LS
Category	Earthen Levee			GPS Latitude/Longitude	
				Start	End
Item	Vegetation			38.732967 °	38.743596 °
				-121.679196 °	-121.689011 °
DWR ID	DWR_NA0008_02_s _ 2018_21				
Comment Code					
V1 : Control annual grass and weeds on the levee slopes and easements.					
Inspector Comment

View of vegetation on the landside slope. Spring 2018.

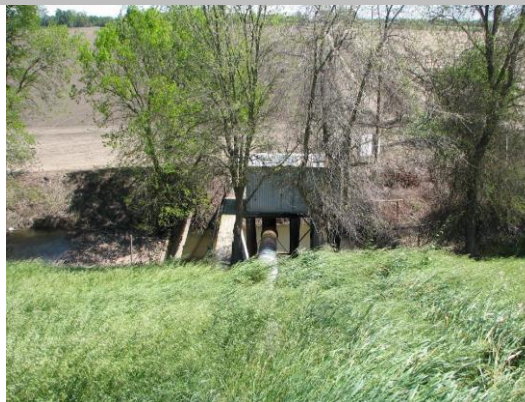
Photo 1 of 3 : UCIP_SP_2018_11293_18675.jpg

Pump on LS toe.

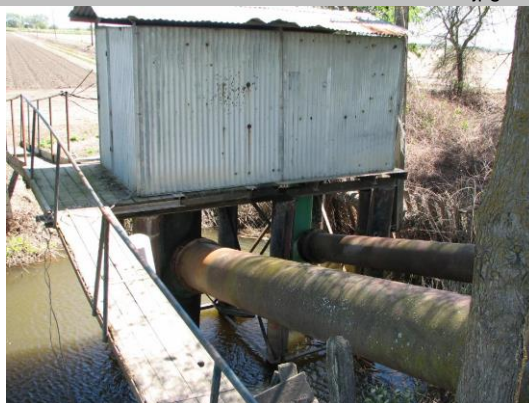
Photo 2 of 3 : UCIP_SP_2018_11293_18674.jpg

Pump and pipes on LS toe.

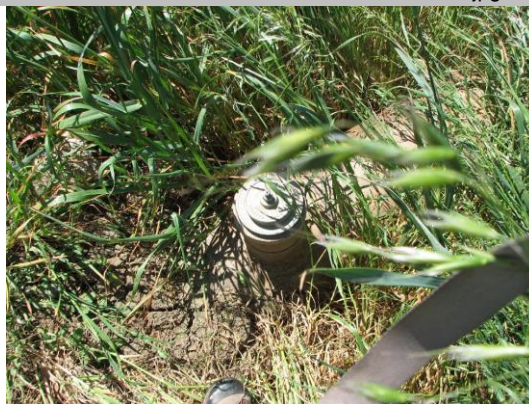
Photo 3 of 3 : UCIP_SP_2018_11293_18673.jpg

16-inch pipe with siphon breaker on WS shoulder.

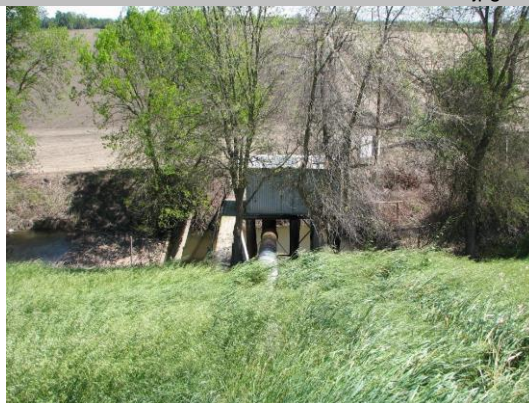
Photo 1 of 3 : UCIP_SP_2018_11291_18669.jpg

Pumphouse at LS toe.

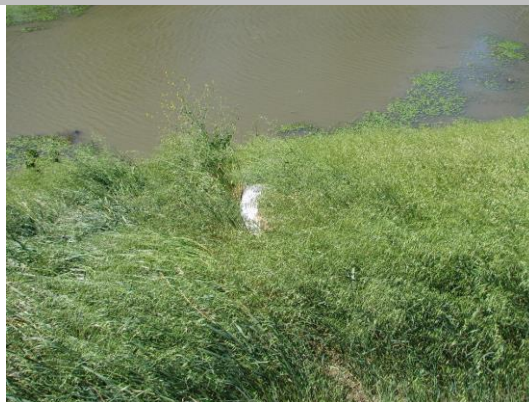
Photo 2 of 3 : UCIP_SP_2018_11291_18668.jpg

Pipe in grass on WS shoulder.

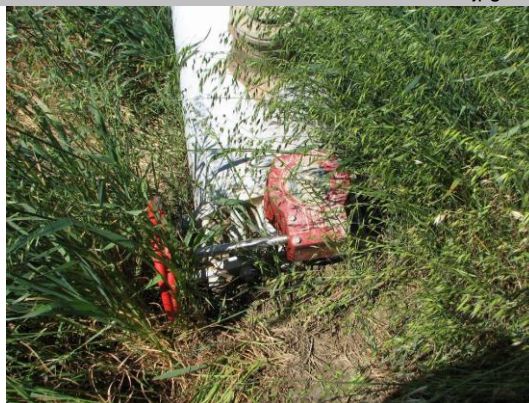
Photo 3 of 3 : UCIP_SP_2018_11291_18667.jpg

Siphon breaker and butterfly valve on WS shoulder.
